Washington County Judicial Ditch #2 Repair Report

October 29, 2004

Goals for the Repair of Judicial Ditch 2

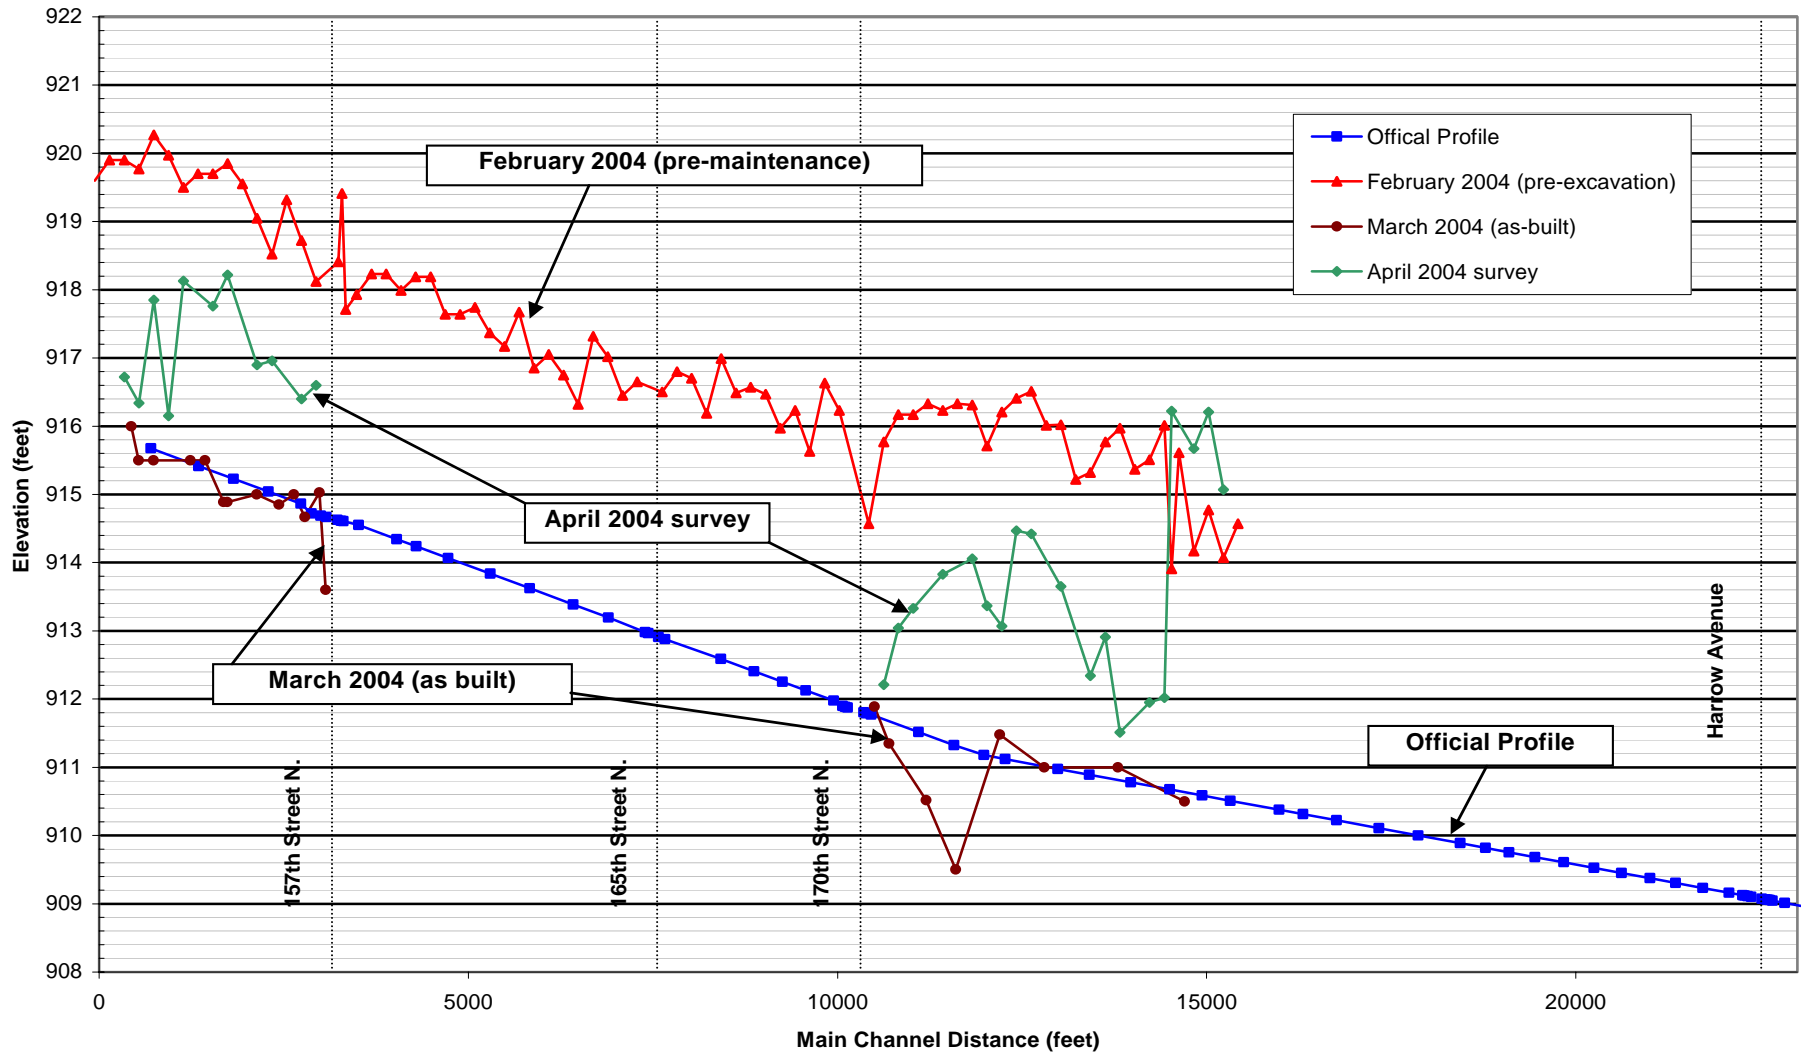
Figure 5. Effects of Minor Maintenance on JD2 Channel Elevation

Results of surveys (Figure 5) indicate that the channel was initially excavated roughly to the Official Profile, and that one month later, the channel bottom elevation had migrated approximately halfway back up to pre-excavation conditions. This is consistent with the failure mechanism described in the soil stability section and shown in Appendix C, which occurs when excavation is below the root zone.

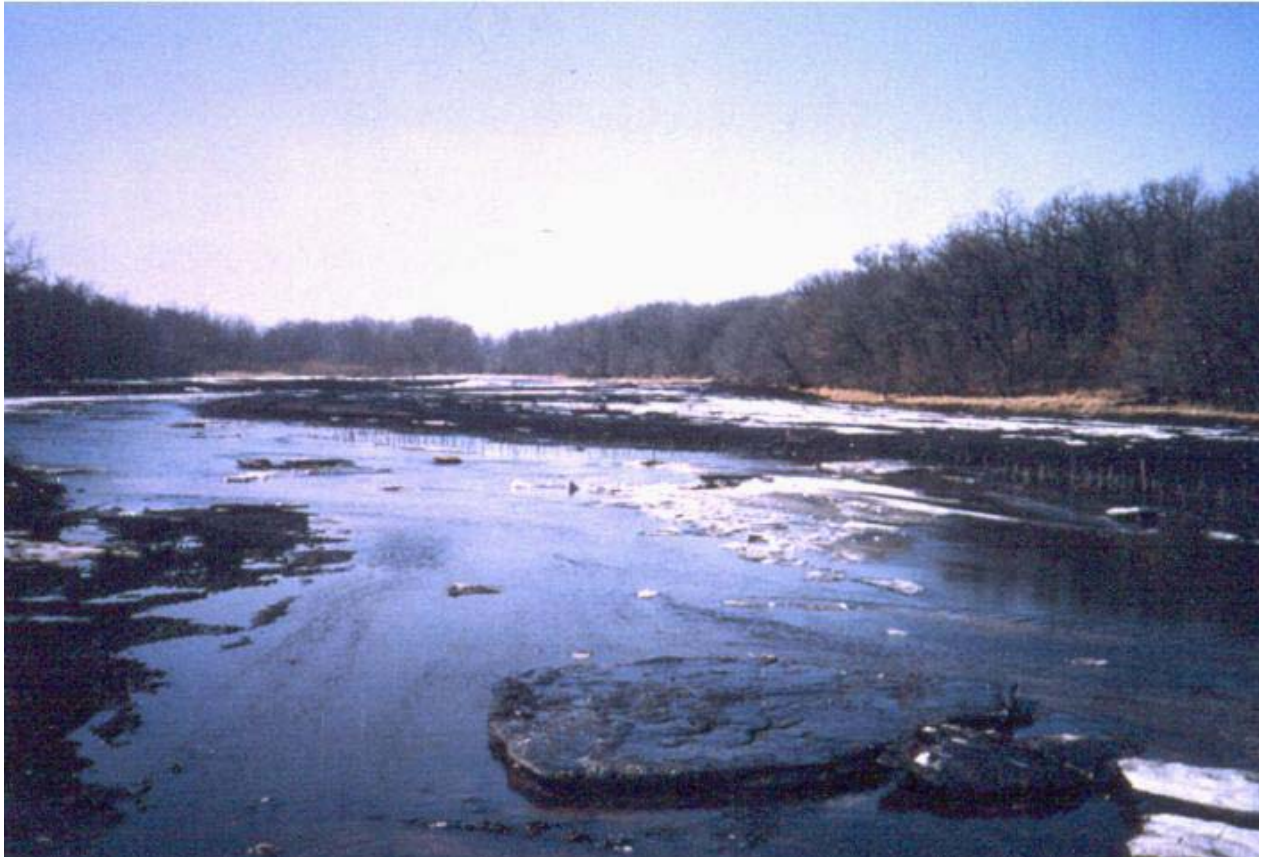
Image 1. Root River at Stewartville, MN after excavation of an over-wide and over-deep channel.

The meandered channel at the official profile alternative has less risk of failure than a traditional ditch repair due to the wider cross section. However, since this alternative requires excavation into unconsolidated peat at the official profile, there is the risk that, just like the traditional repair, the resulting channel will not maintain its design configuration. Image 1 shows the problems associated with excavating an over-wide and deep channel.
